**DAM INSPECTION REPORT**  
**Lake Elbo Dam**  
**Water Structure No. DPT-0055 (NID: KS02061)**

**Inspection Date: April 15, 2025**

**Report Prepared by: Abby Mills, PE, CFM**  
BG Consultants, Inc.  
4806 Vue Du Lac Place  
Manhattan, KS 66503  
785-537-7448  
BG Project #25-1178M

**Owner of Dam: Lake Elbo Club, Inc.**  
5629 Elbo Shore Drive  
Manhattan, KS 66502  
(785) 323-7667

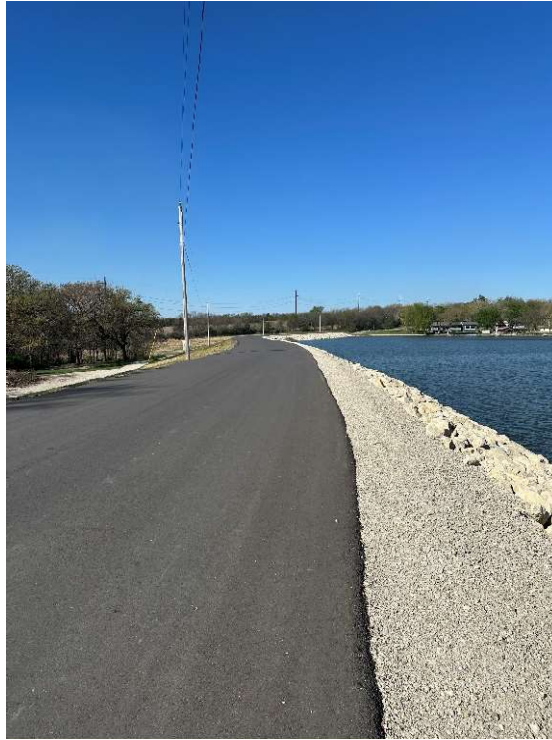
**Photo #1:** Standing on left side (east) of the abutment looking west on top of dam.

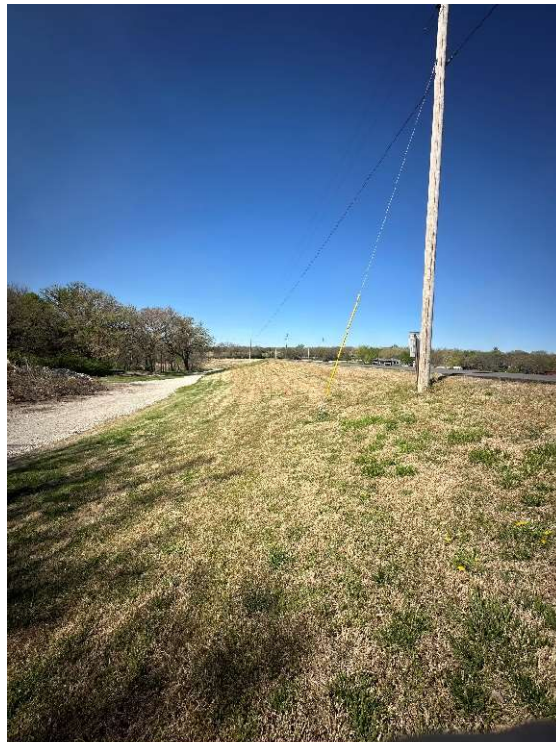
inspection. There are utility poles located along the downstream slope of the dam (Photos 2, 19, & 20).

**Photo #2:** Standing on the left (east) embankment looking at the downstream slope.

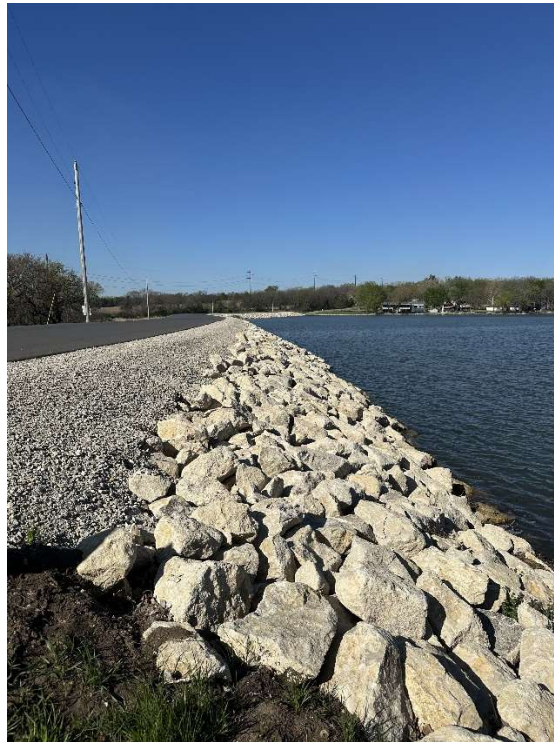
- **Seepage** – No seepage locations were noted during the current inspection. Overall soil/ground conditions were dry.
- **Wave Erosion/Rip Rap** – The reservoir was at normal pool elevation appears to be performing sufficiently (Photos 5, 6, & 9). Rip rap wave protection has recently been installed to prevent erosion (Photo 3). There does not appear to be any scarping along the shoreline.

**Photo #3:** Standing on the left (east) abutment looking at the upstream slope.

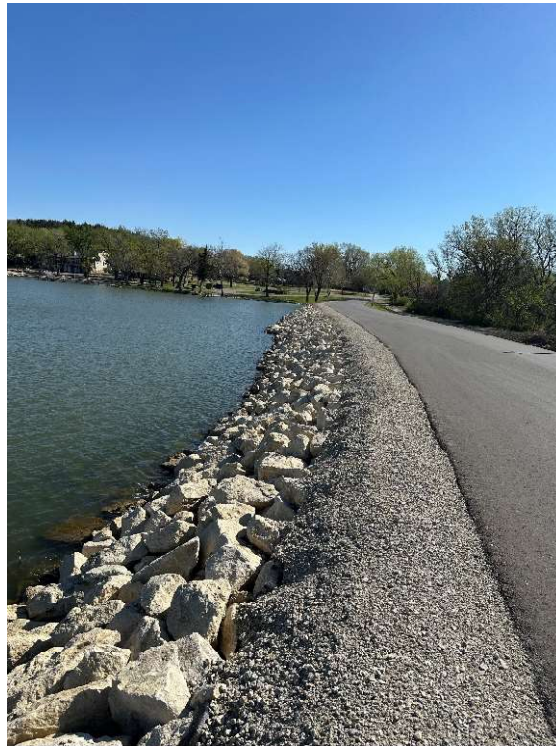
**Photo #5:** Standing near primary spillway looking east at the upstream slope, rip rap erosion protection.

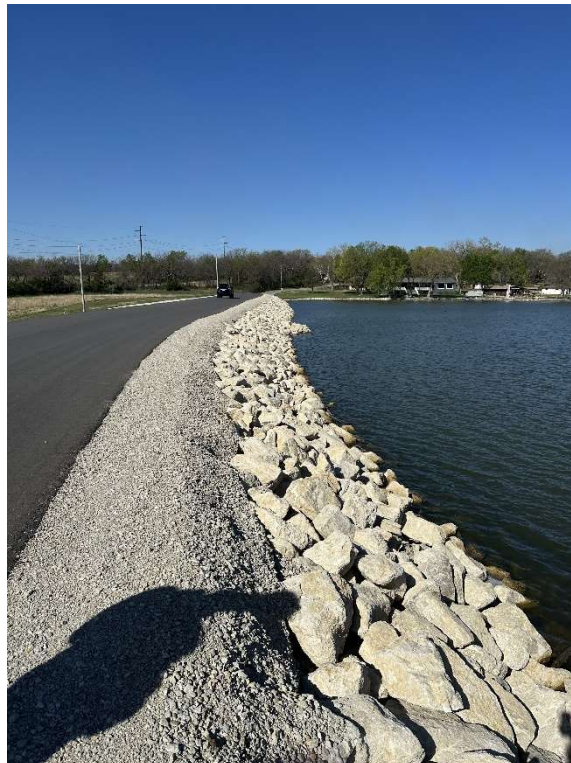
**Photo #6:** Standing near primary spillway looking west at upstream slope, rip rap erosion protection.

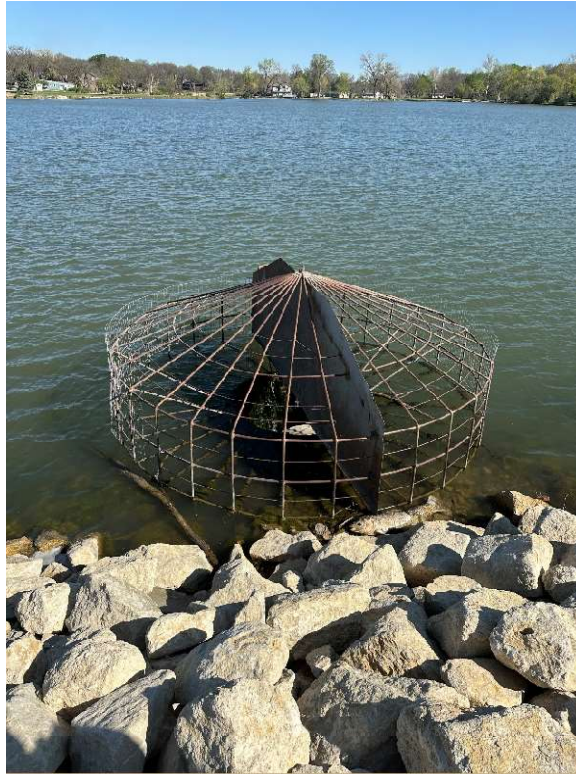
- **Primary Spillway Intake** – The primary spillway appears to be in good condition. There is no debris blocking the inflow. The trash rack and anti-vortex plate appear to be operating as intended (Photos 7 & 8). A reservoir drawdown valve was operated sometime in 2023/2024.

**Photo #7:** Primary spillway intake, CMP riser with trash rack and vortex plate.

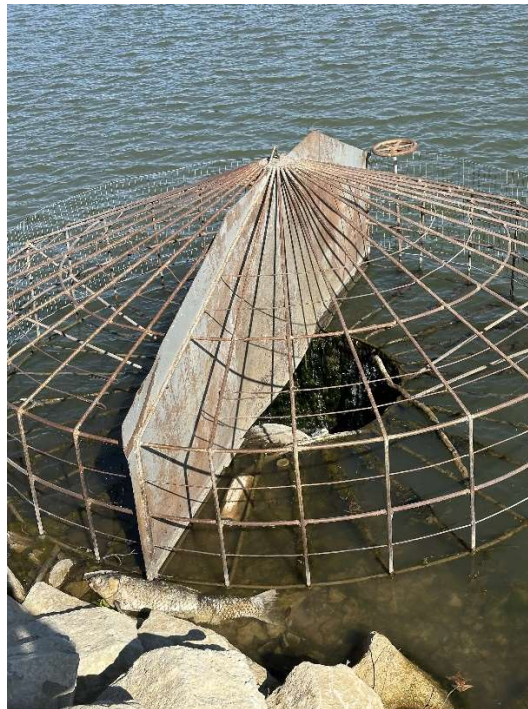
**Photo #8:** Primary spillway intake, CMP riser with trash rack and vortex plate.

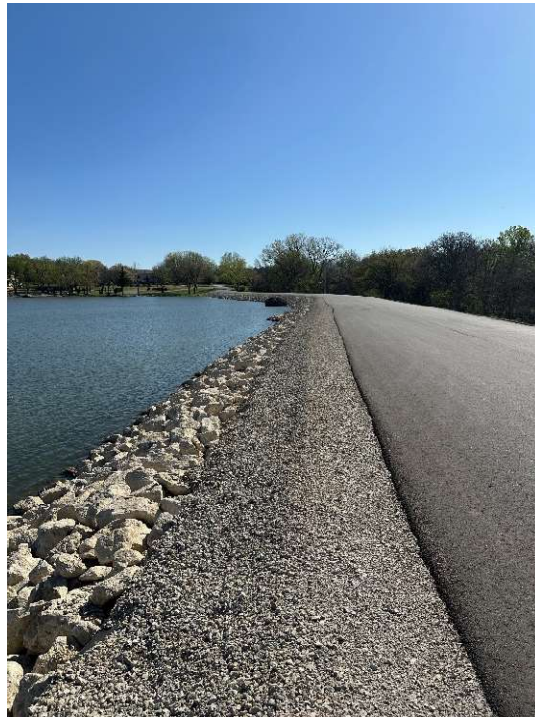
**Photo #9:** Standing on right (west) abutment looking east at upstream slope.

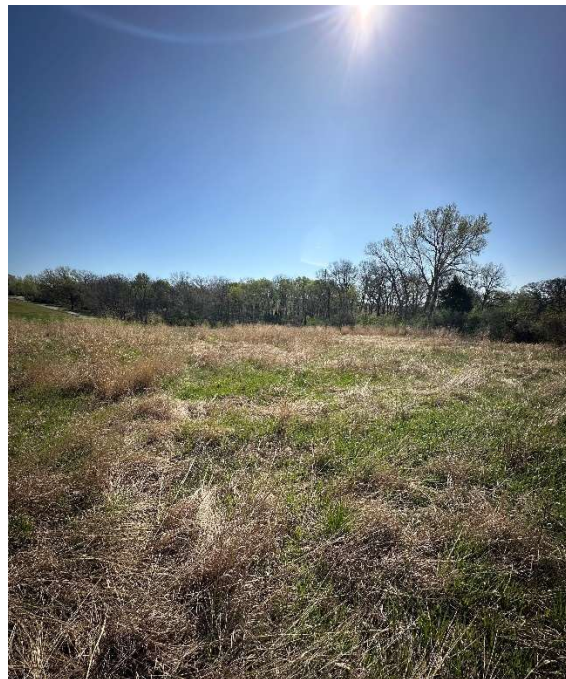
- **Trees, Brush, and Grass Cover on Dam** – The dam owner has done a good job at keeping saplings/woody vegetation from growing on the embankment (See Photo Log). A good stand of grass is present throughout the embankment. Brushy vegetation is present along the auxiliary spillway (Photos 14, 15, & 16).

**Photo #14:** Looking downstream on auxiliary spillway.

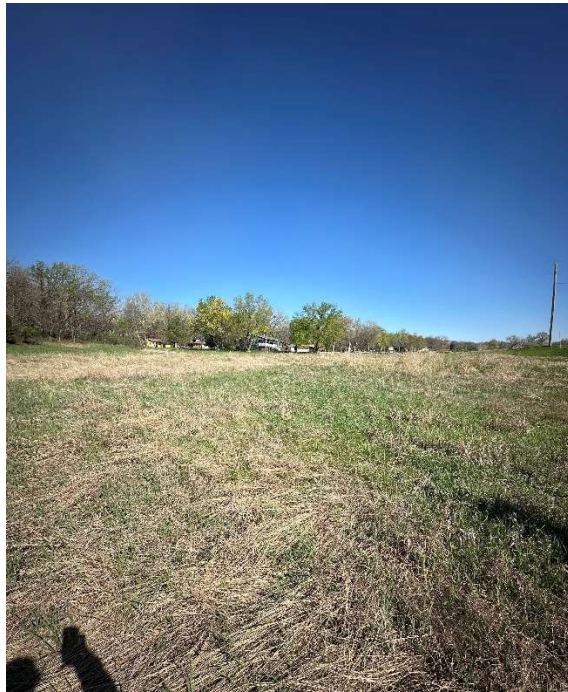
**Photo #15:** Looking upstream on auxiliary spillway.

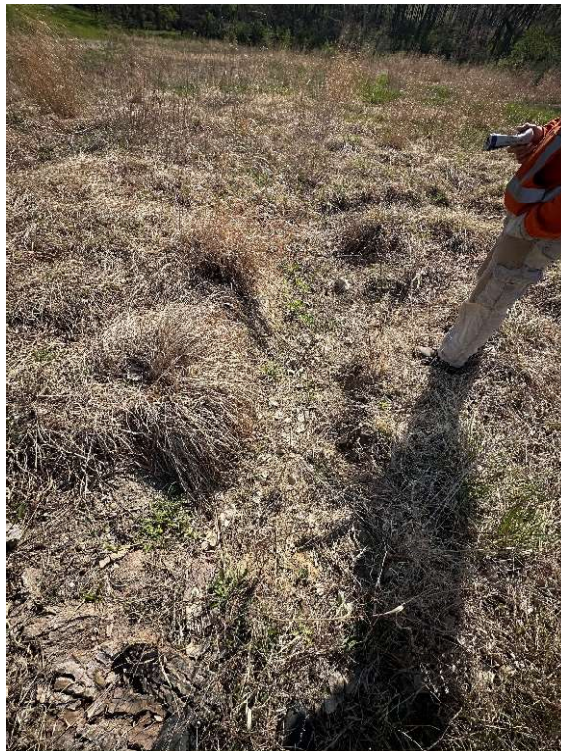
- **Auxiliary Spillway** – There are two areas of erosion along the middle of the spillway approximately midway through and along the west side (Photos 16 & 17). Routine maintenance is planned to prevent further erosion. Other than the noted erosion, the auxiliary spillway is in good condition with adequate grass cover. A log jam was forming at the auxiliary spillway entrance to Elbo Creek (Photo 18).

**Photo #16:** Looking south (downstream) in auxiliary spillway channel, erosion.

1. Repair the erosion area in the middle of the auxiliary spillway channel floor. Based on previous inspections, these areas of erosion will require routine maintenance.

1. Monitor minor erosion areas along the auxiliary spillway.
2. Continue vegetation control activities through burning, mowing, and routine removal of undesirable vegetation.
3. Continue periodic updates of the EAP as required by Kansas rules and regulations governing water structures of this type.

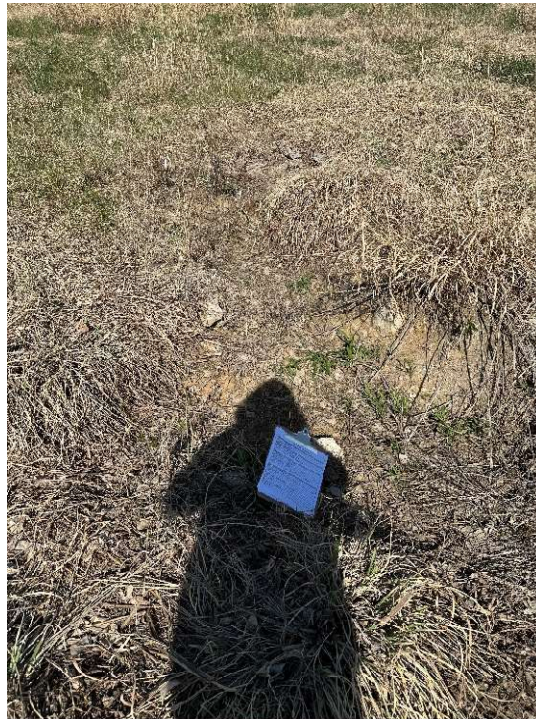
**Photo #17:** Looking south (downstream) in auxiliary spillway channel, erosion.

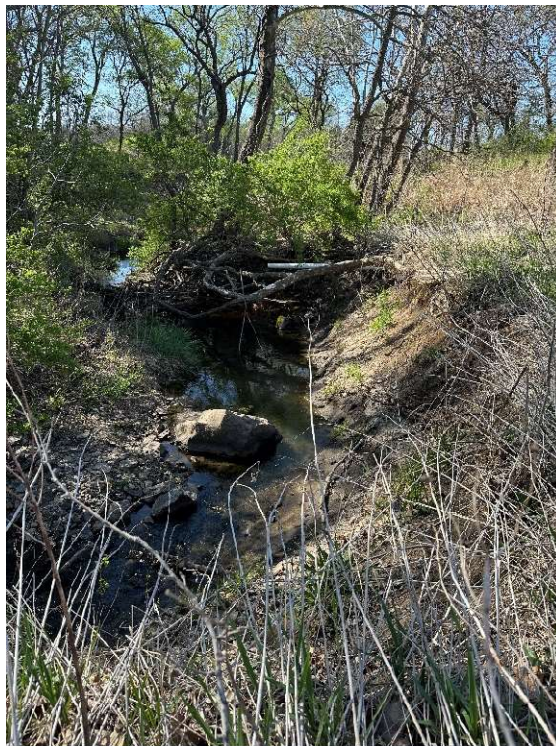
**Photo #18:** Looking at creek that auxiliary spillway channel flows into.

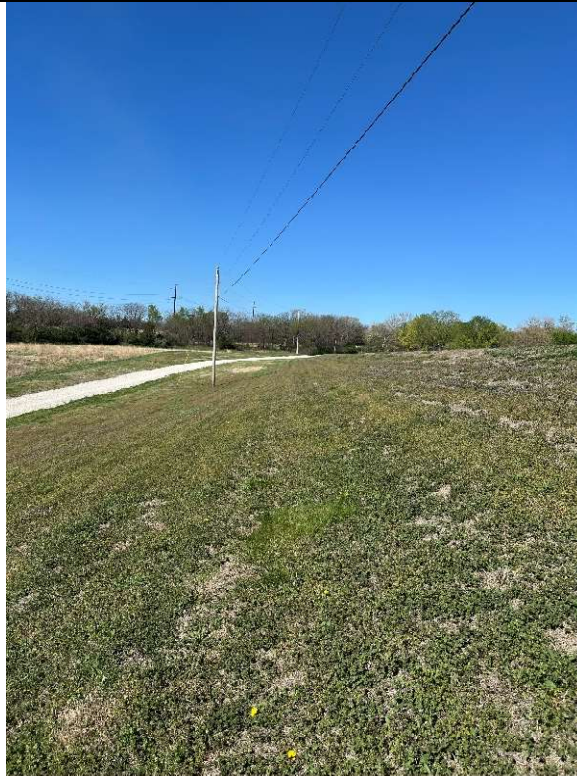
**Photo #19:** Power poles running along downstream slope of embankment. Power poles appear to be above the normal pool elevation.

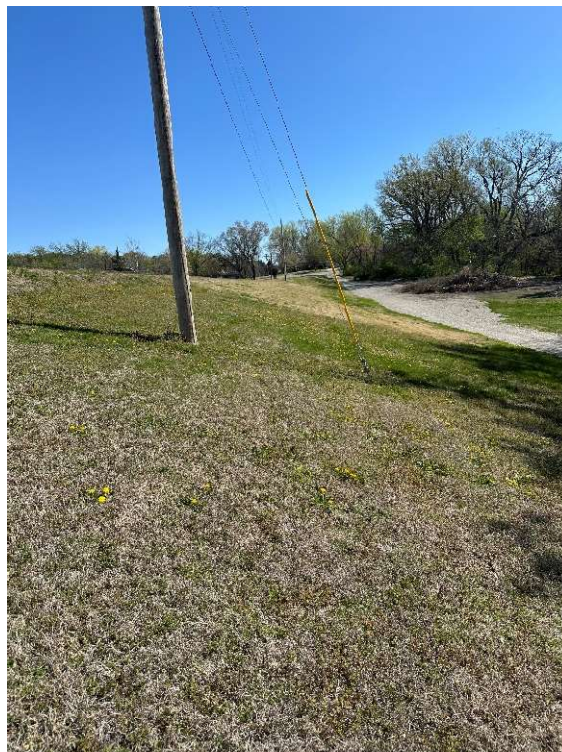
**Photo #20:** Looking east at downstream embankment, power pole.

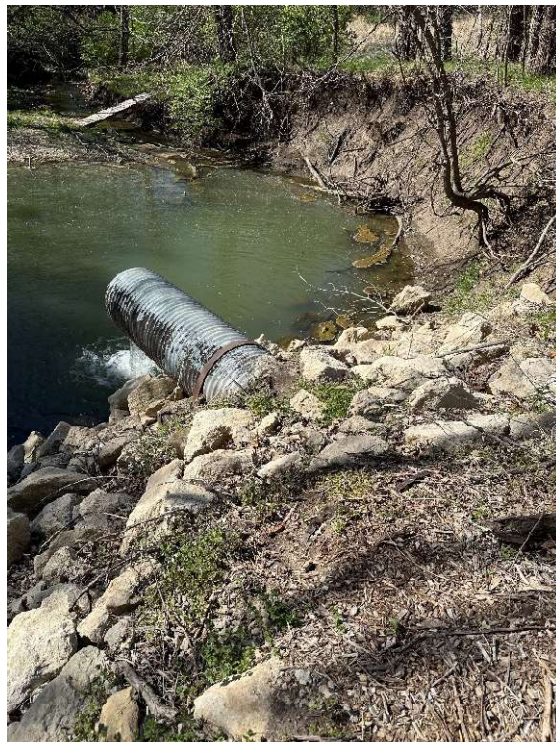
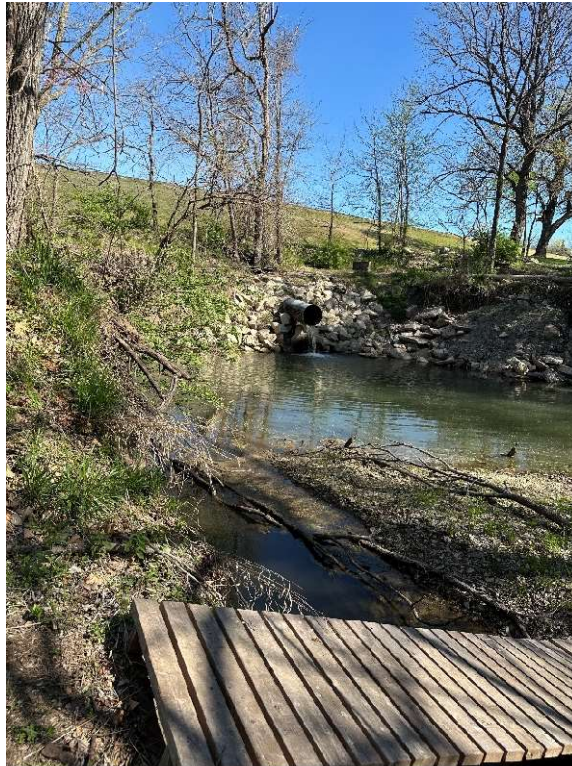
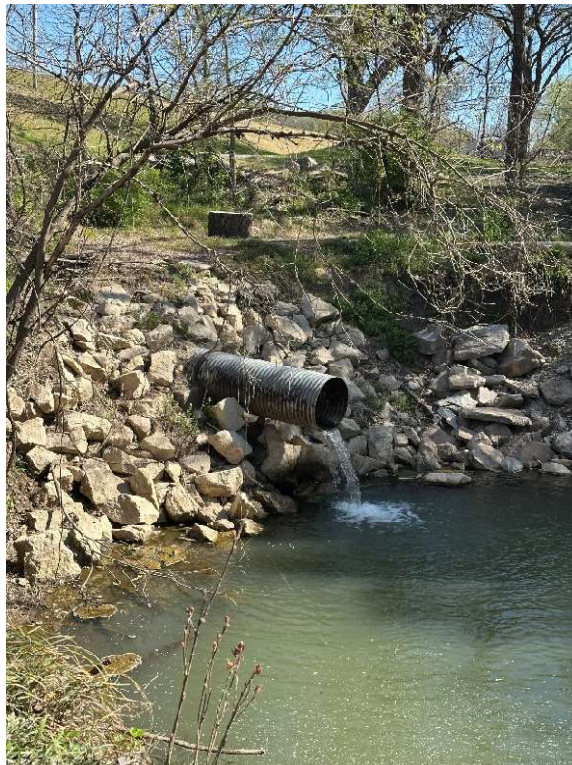
- **Primary Spillway Outlet** – The primary spillway outlet was flowing approximately 3 cfs at the time of inspection. The spillway outlet appeared to be operating as intended. The club recently completed a project to construct a support for the outlet pipe and line the slope with rip rap to mitigate erosion (Photos 22, 23, & 24). Trees and other vegetation have been removed around the outlet to allow better access for maintenance activities (Photos 22, 23, & 24).

**Photo #22:** Primary spillway outlet.

**Photo #23:** Primary spillway outlet.

**Photo #24:** Primary spillway outlet.
